**Description:** RFI 124 City Hall: Masonry Parapet @ Existing Building

**Subject:** City Hall: Masonry Parapet @ Existing Building

**Drawing:** B3/A525  
**Cost Impact:** TBD

**PROJECT NAME:**  
 Bonner Springs - Govt. Services City Hall  
 200 E. 3rd St.  
 Bonner Springs, KS 66012

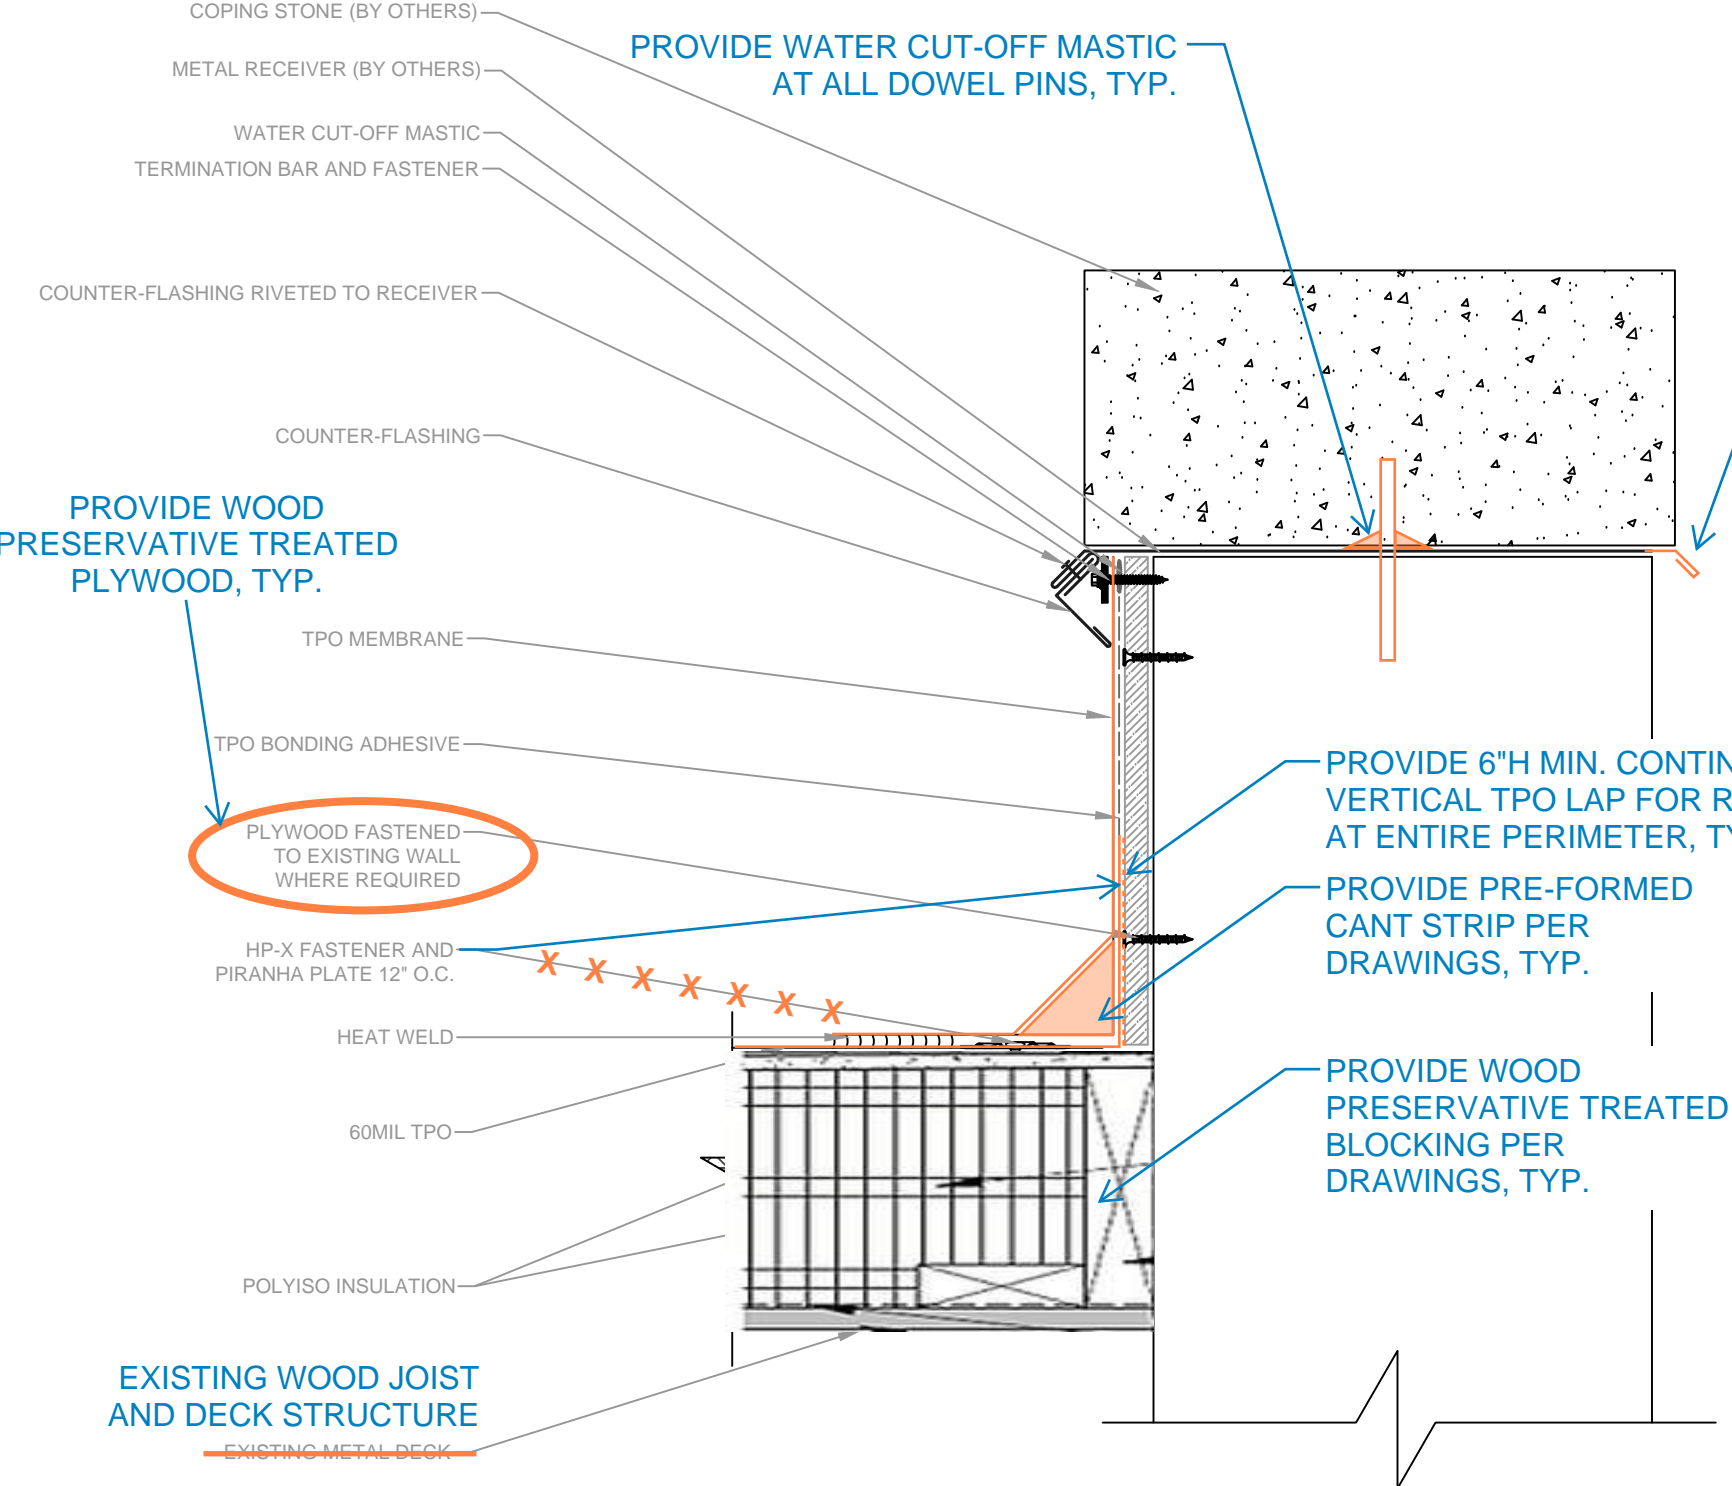
**PROVIDE 1/2" OVERLAP PER DRAWINGS, TYP.**

**PROVIDE WOOD PRESERVATIVE TREATED PLYWOOD, TYP.**

**PROVIDE 6"H MIN. CONTINUOUS VERTICAL TPO LAP FOR REDUNDANCY AT ENTIRE PERIMETER, TYP.**

**PROVIDE PRE-FORMED CANT STRIP PER DRAWINGS, TYP.**

**PROVIDE WOOD PRESERVATIVE TREATED BLOCKING PER DRAWINGS, TYP.**

**PLYWOOD FASTENED TO EXISTING WALL WHERE REQUIRED**

**HP-X FASTENER AND PIRANHA PLATE 12" O.C.**

**EXISTING WOOD JOIST AND DECK STRUCTURE**  
**EXISTING METAL DECK**

SEE ATTACHED MARK-UPS TO ROOF PARAPET DETAIL SUBMITTED FOR DIRECTION.
