**Change Request**

**Number:** 44  
**Date:** 2/14/20  
**Job:** 19050 Bonner Springs Govt Services  
**Phone:**

**Description:** RFI 75 & 122 Additional Wood Framing

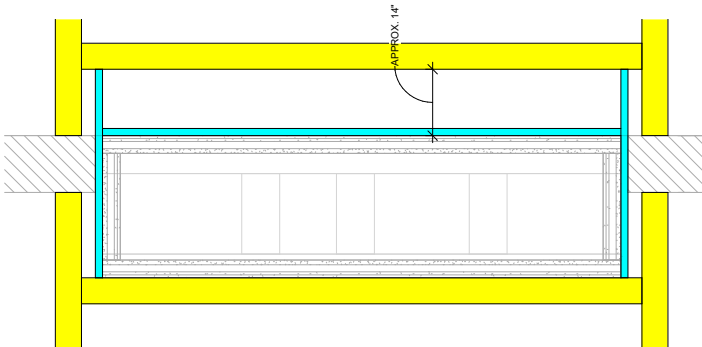
Provide new 2x12 framing as shown in blue below. New framing needs to be clear of new shaft wall to allow wall to be continuous.  
 -Ryan Hagedorn / BDC / 11-2-19

RFI 75 City Hall: Floor Loading Support Details @ New Mechanical Chase  
additional LVL framing

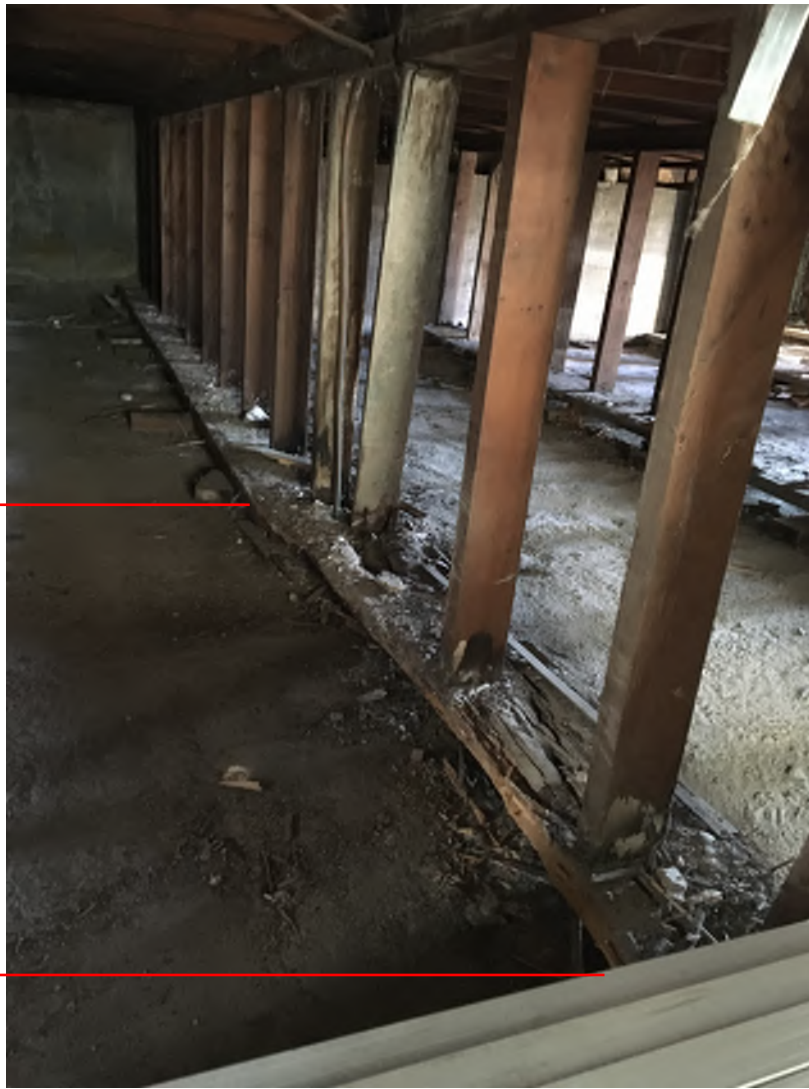
REPLACE DAMAGED SEGMENT OF SILL PLATE

**Response:** Existing stage construction was reviewed on site 12/3/19. The majority of existing wood framing appeared to be in adequate condition. Water, termite, or otherwise damaged members should be removed and replaced with new dimensional lumber matching size and location of existing. The level of damage which requires replacement was discussed and indicated on site. Example photos have also been attached to this RFI for reference. If there are additional questions about individual members not reviewed on site, BDC can review and direct.

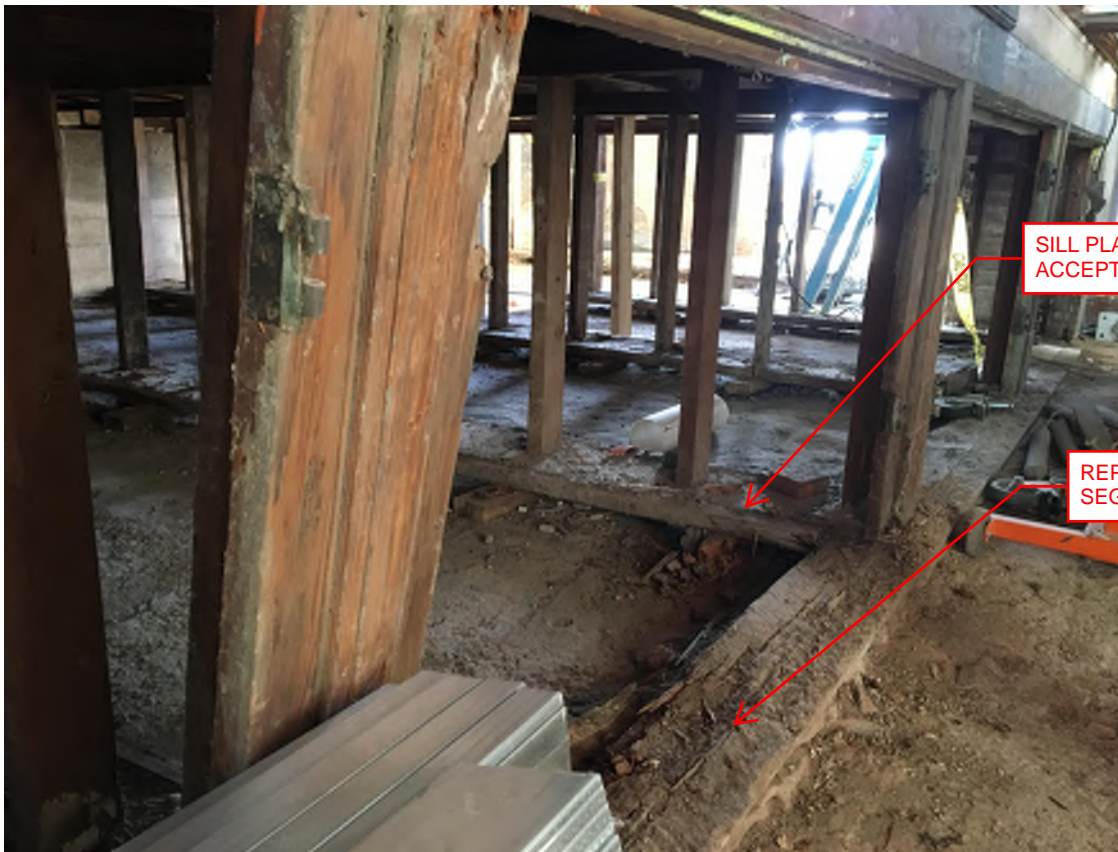
SILL PLATE IS IN ACCEPTABLE CONDITION

REPLACE DAMAGED SEGMENT OF SILL PLATE
